Manhole Inspection Summary

Manhole # S53C__046MH

Insp Date: **6/20/08 9:52 AM**

Location Address: **rear 11 n clinton st**

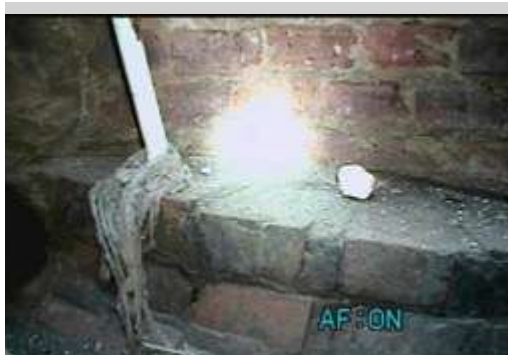
Defect 3

bench debris

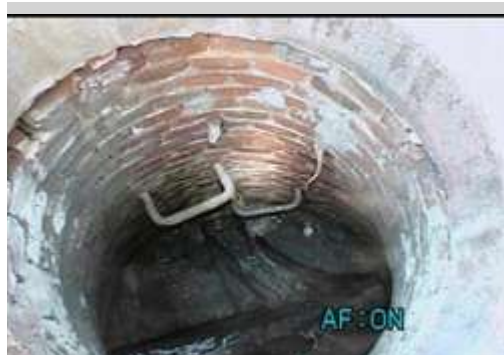
Defect 2

Steps Count: **3** Missing: **1** ☒ **Corroded**

corroded & missing steps

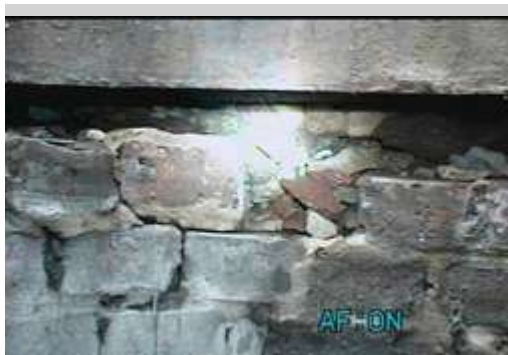
Defect 1

Condition: ☐ Sound ☐ Cracked ☐ Root Intrusion ☒ **Loose Brick** ☐ Deteriorated

loose bricks corbel

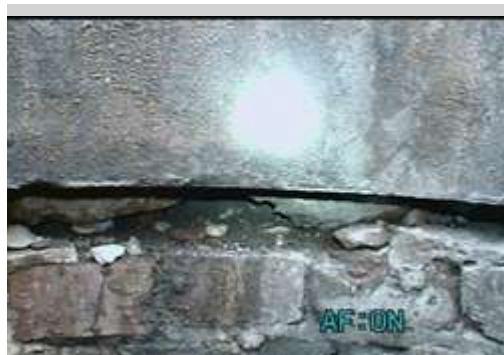
Condition: ☐ Sound ☐ Cracked ☐ Root Intrusion ☒ **Loose Brick** ☒ **Deteriorated**

chimney loose bricks & deteriorated frame adj
